MERRIMACK RIVER BASIN
LEOMINSTER, MASSACHUSETTS

NOTOWN RESERVOIR DAM AND DIKE

PHASE I INSPECTION REPORT NATIONAL DAM INSPECTION PROGRAM

MARCH 1980

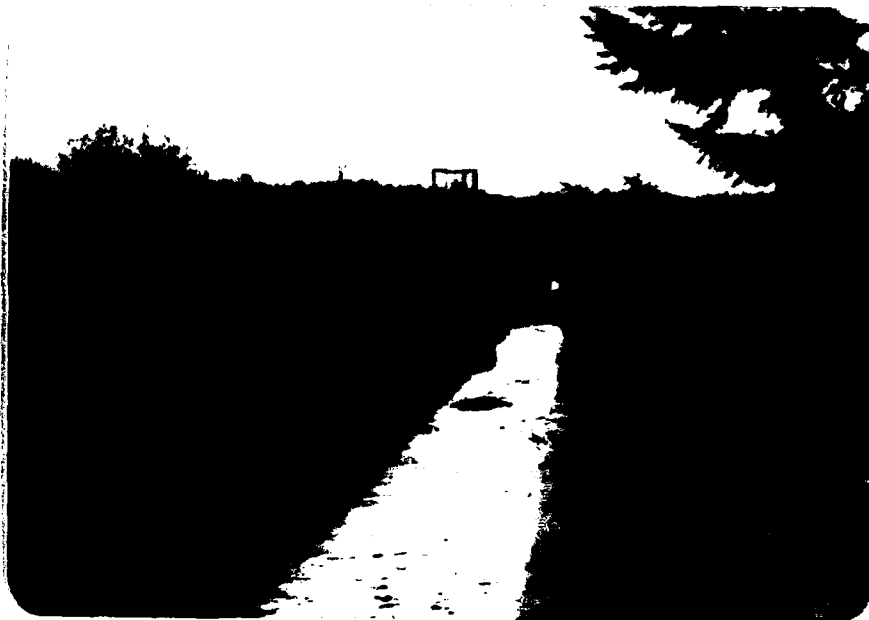
PHOTO NO. 3 - This photo shows the water supply outlet channel, looking toward the Dam. The channel has concrete capped stone masonry walls with a gravel bottom.

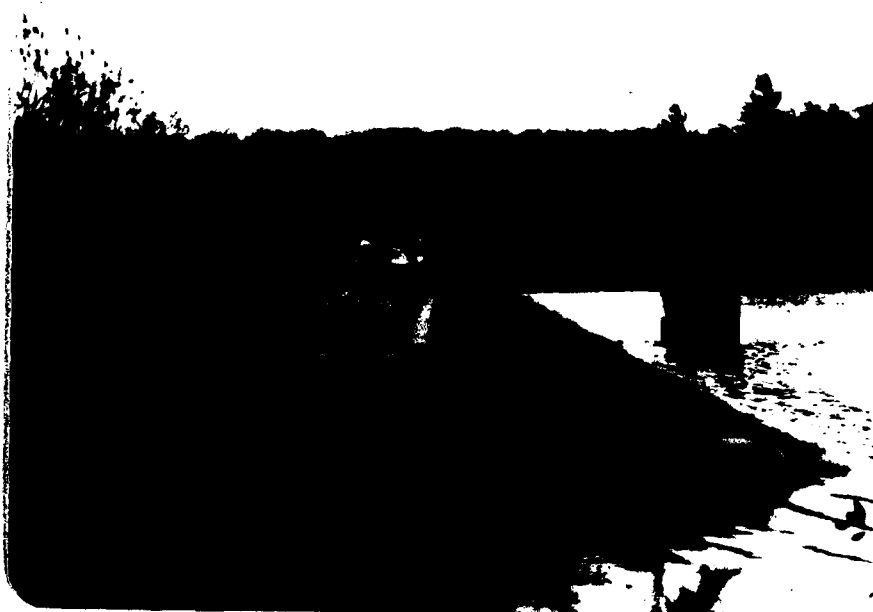
Upstream of the spillway weir, the spillway training walls consist of dry masonry stone walls which have been pointed in some areas, photographs 4 and 6. The training walls downstream of the weir consist of mortared masonry stone walls covered with a thin layer of concrete, as shown in photographs 6 and 15. The concrete is spalling in some sections of the walls.

PHOTO NO. 4 - This photo was taken from the left abutment area looking across the spillway (foreground) along the top of Dam. Note the top of the concrete core wall, concrete masonry intake structure; and the elevation of the intake structure service bridge.

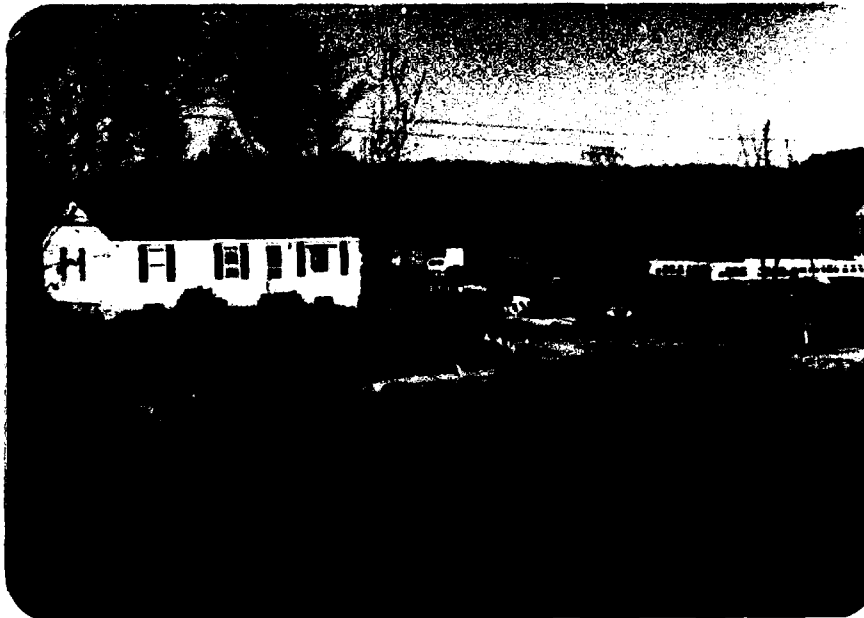
PHOTO NO. 24 - This view shows the downstream area near the left abutment and center of the Dike. This area is within the Dam failure impact area. Flood stage could be 5 feet deep or more.
